Docket No. 217 – Development and Management Plan Inspection

Northeast Utilities Service Company Certificate of Environmental Compatibility and Public Need for the construction of a 345-kV electric transmission line and reconstruction of an existing 115-kV electric transmission line between Connecticut Light and Power Company's Plumtree Substation in Bethel, through the towns of Redding, Weston, and Wilton, and to the Norwalk Substation in Norwalk, Connecticut.

Date: August 16, 2006

Location: Transition Stations: Hoyts Hill, Archers Lane, Norwalk Junction

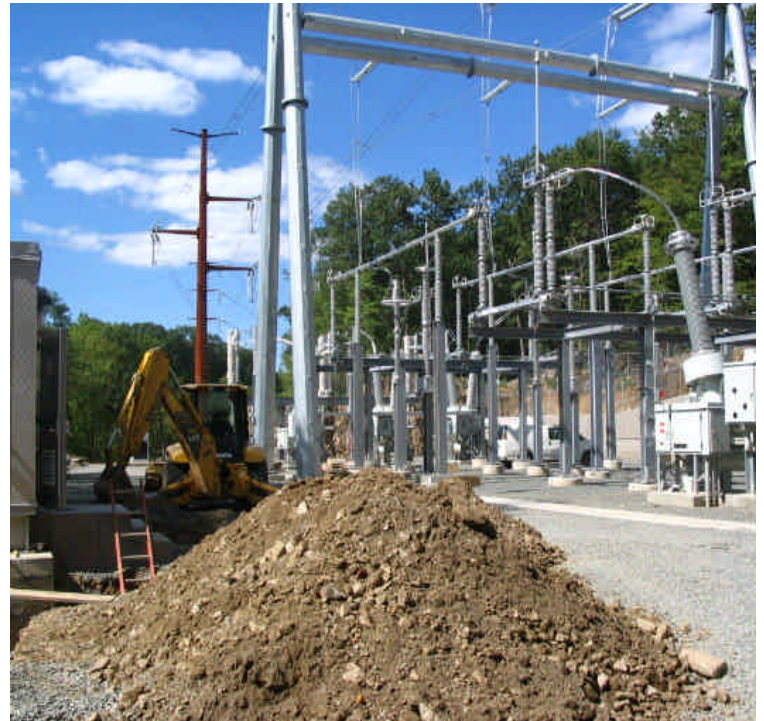
Photo on the left shows the wetland at the base of slope at Hoyts Hill. Timber mats were removed and the area was restored by 345kV XLPE crews. Archers Lane: Photo on the right shows an overview of the station yard. Stone was placed in the yard and some small areas of excavation were present. 8/16/06

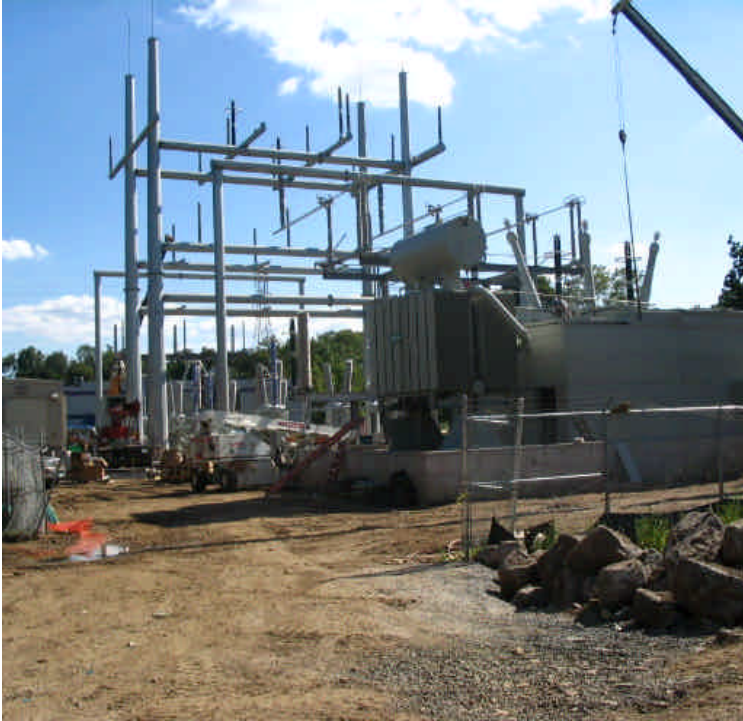
Norwalk Junction: Photo on the left shows an overview of the structure and form work in the yard. Photo on the right shows where the swale was regraded after being filled in for access. Replace stone and revegetate the swale for stabilization 8/16/06.
